AI-assisted inspection of concrete surfaces at dams

Ephraim Friedli – Axpo Power AG

Stefan Schuhbäck – Verbund Hydro Power GmbH

vgbe / Verbund Expert Event
Digitalization in Hydropower - Vienna 17./18. November 2022

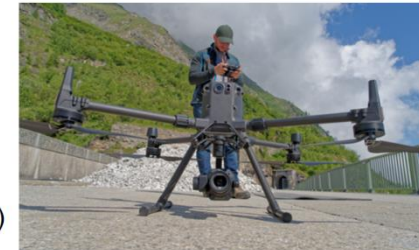
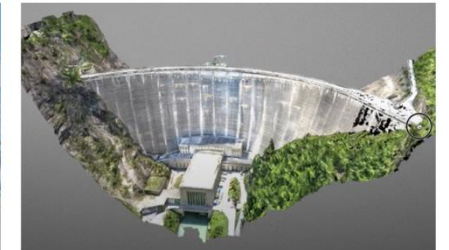
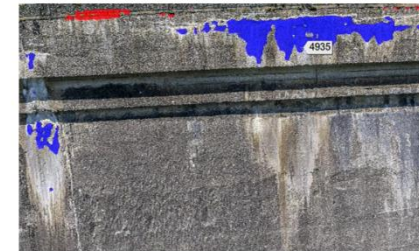
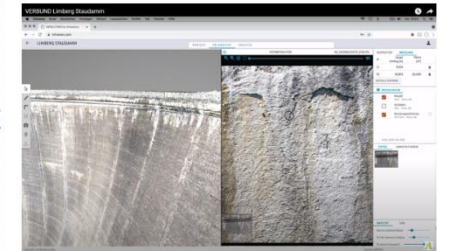
Upgrade to Surface Monitoring

1. Automated aerial survey & Image recording with UAV
2. Photogrammetric 3D reconstruction
3. Automated image analysis using Artificial Intelligence (AI)
4. More detailed visualization, analysis & documentation

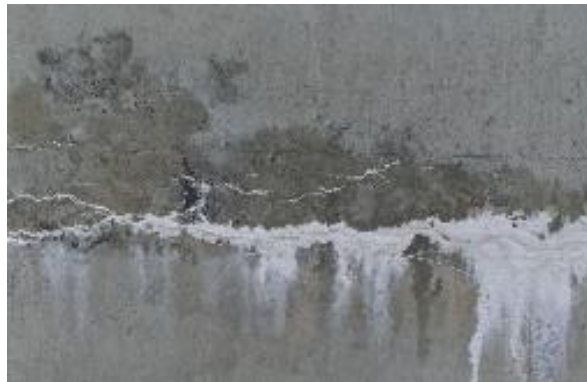
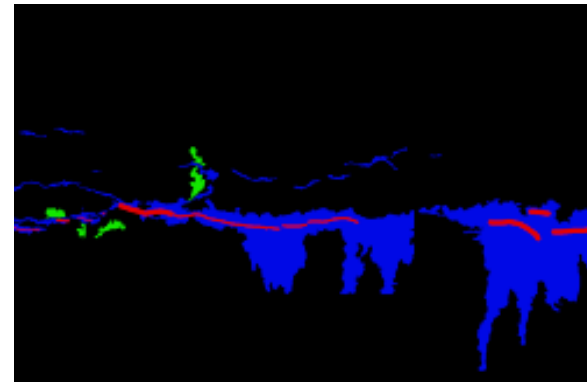
Further training of the detection-algorithm

- Selection of a high resolution image data set representing the characteristic concrete dam surfaces (129 images: 113 for training, 16 as test set)
- Additional classes: crack with efflorescence, joint
- Precise annotation of the abnormalities (pixel precise)

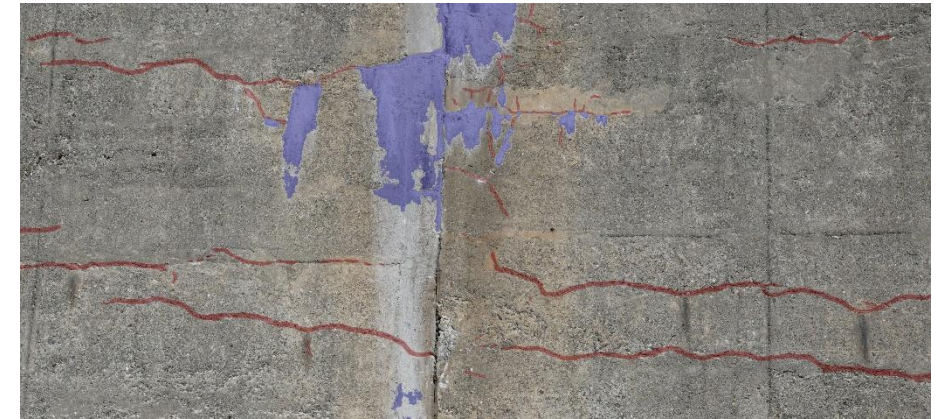
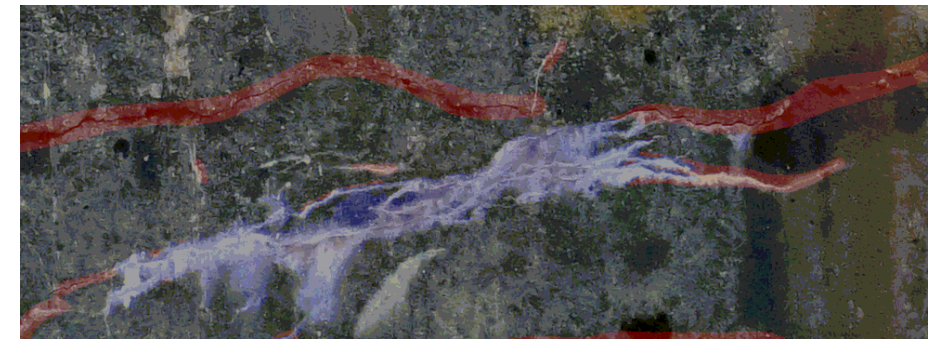
Main sources of error / challenges:

- Insufficient resolution of images
- Sharpness, brightness of images

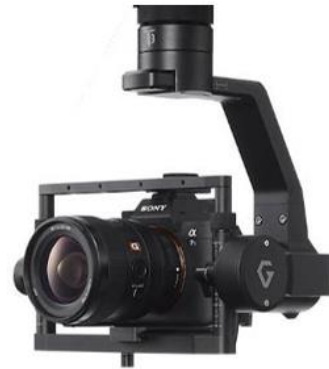
Sony Alpha 7R II

Sensor size [mm]

36 x 24

Megapixel

42,4

Image resolution [pixel]

7952 x 5304

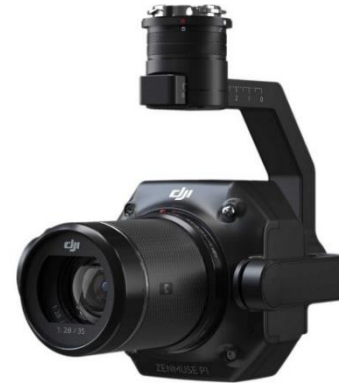
DJI Zenmuse P1

35,9 x 24

45

8192 x 5460

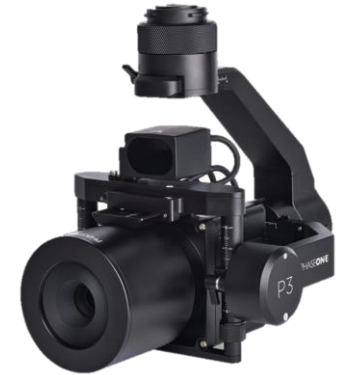
PhaseOne iXM-100

44 x 33

100

11664 x 8750

Laser range finder

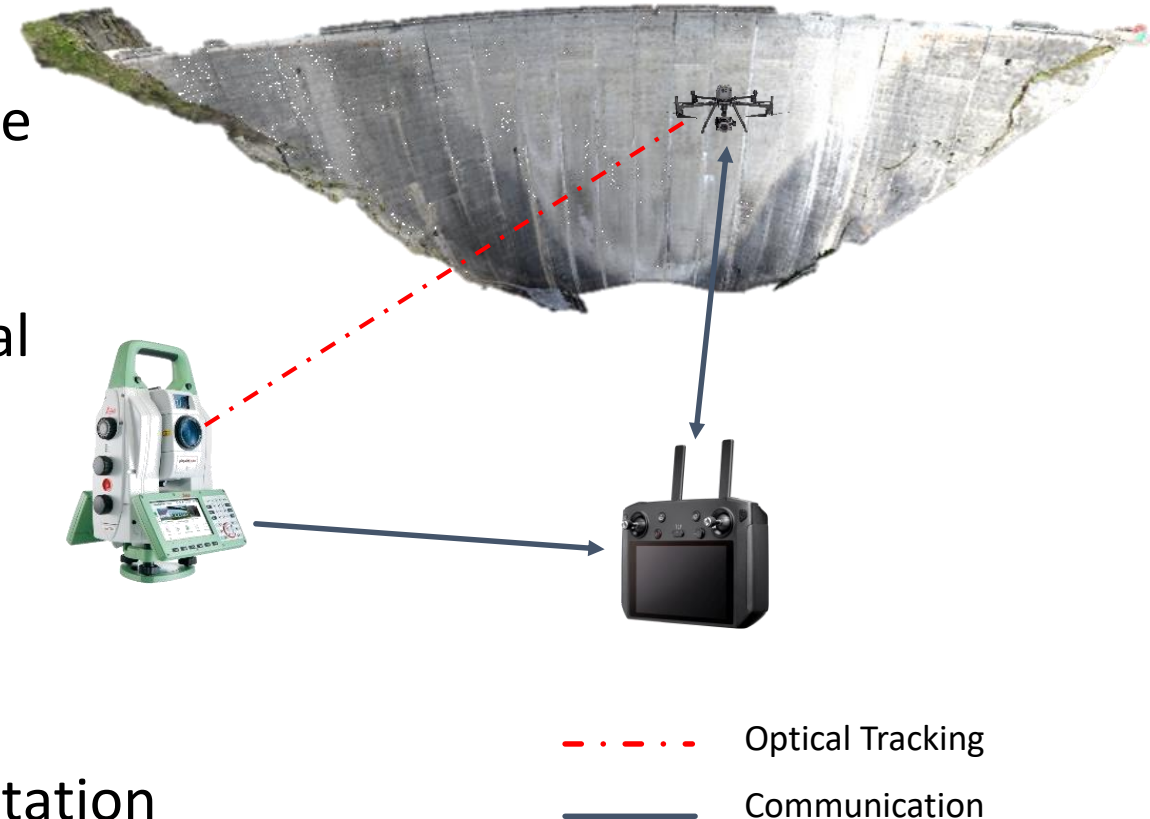
- Autonomous flights close to the dam (<20 m) are challenging ➡ reduced visibility of satellites
- Often a combination of autonomous and manual flights ➡ repeatability not ensured
➡ **Alternative approaches are required**

- Tracking and guidance of the UAV with a total station

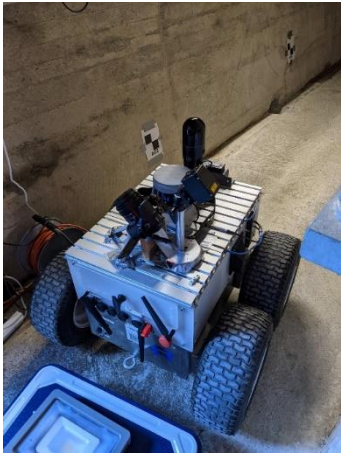
Wheel based vehicles

- + heavy payload
- only for horizontal areas

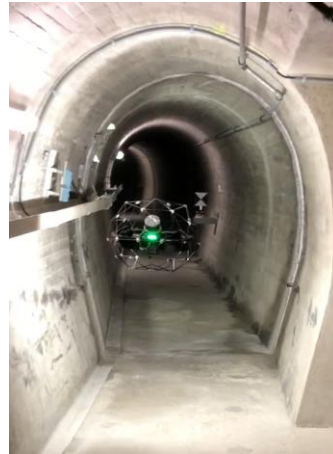
Drones

- + vertical shafts accessible
- limited payload

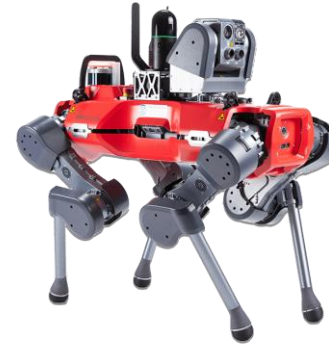
Legged Robots

- + Payload
- vertical shafts not accessible

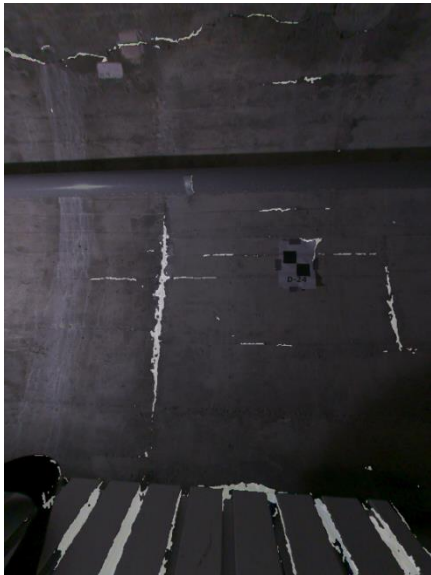
Mobile scanning

- + quick
- resolution not sufficient

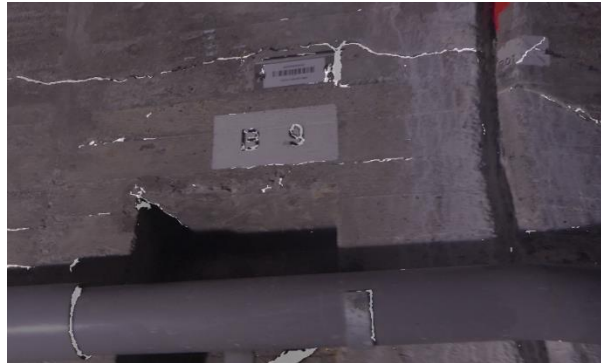
DSLR

- + high resolution
- no scale and geo location
